REPORT OF FATAL COAL OUTBURST (BUMP) ACCIDENT  
KENILWORTH MINE  
THE NORTH AMERICAN COAL CORPORATION, UTAH DIVISION  
KENILWORTH, CARBON COUNTY, UTAH

April 14, 1970

William Bazo  
Federal Coal Mine Inspector

E. J. Grillos  
Mining Engineer

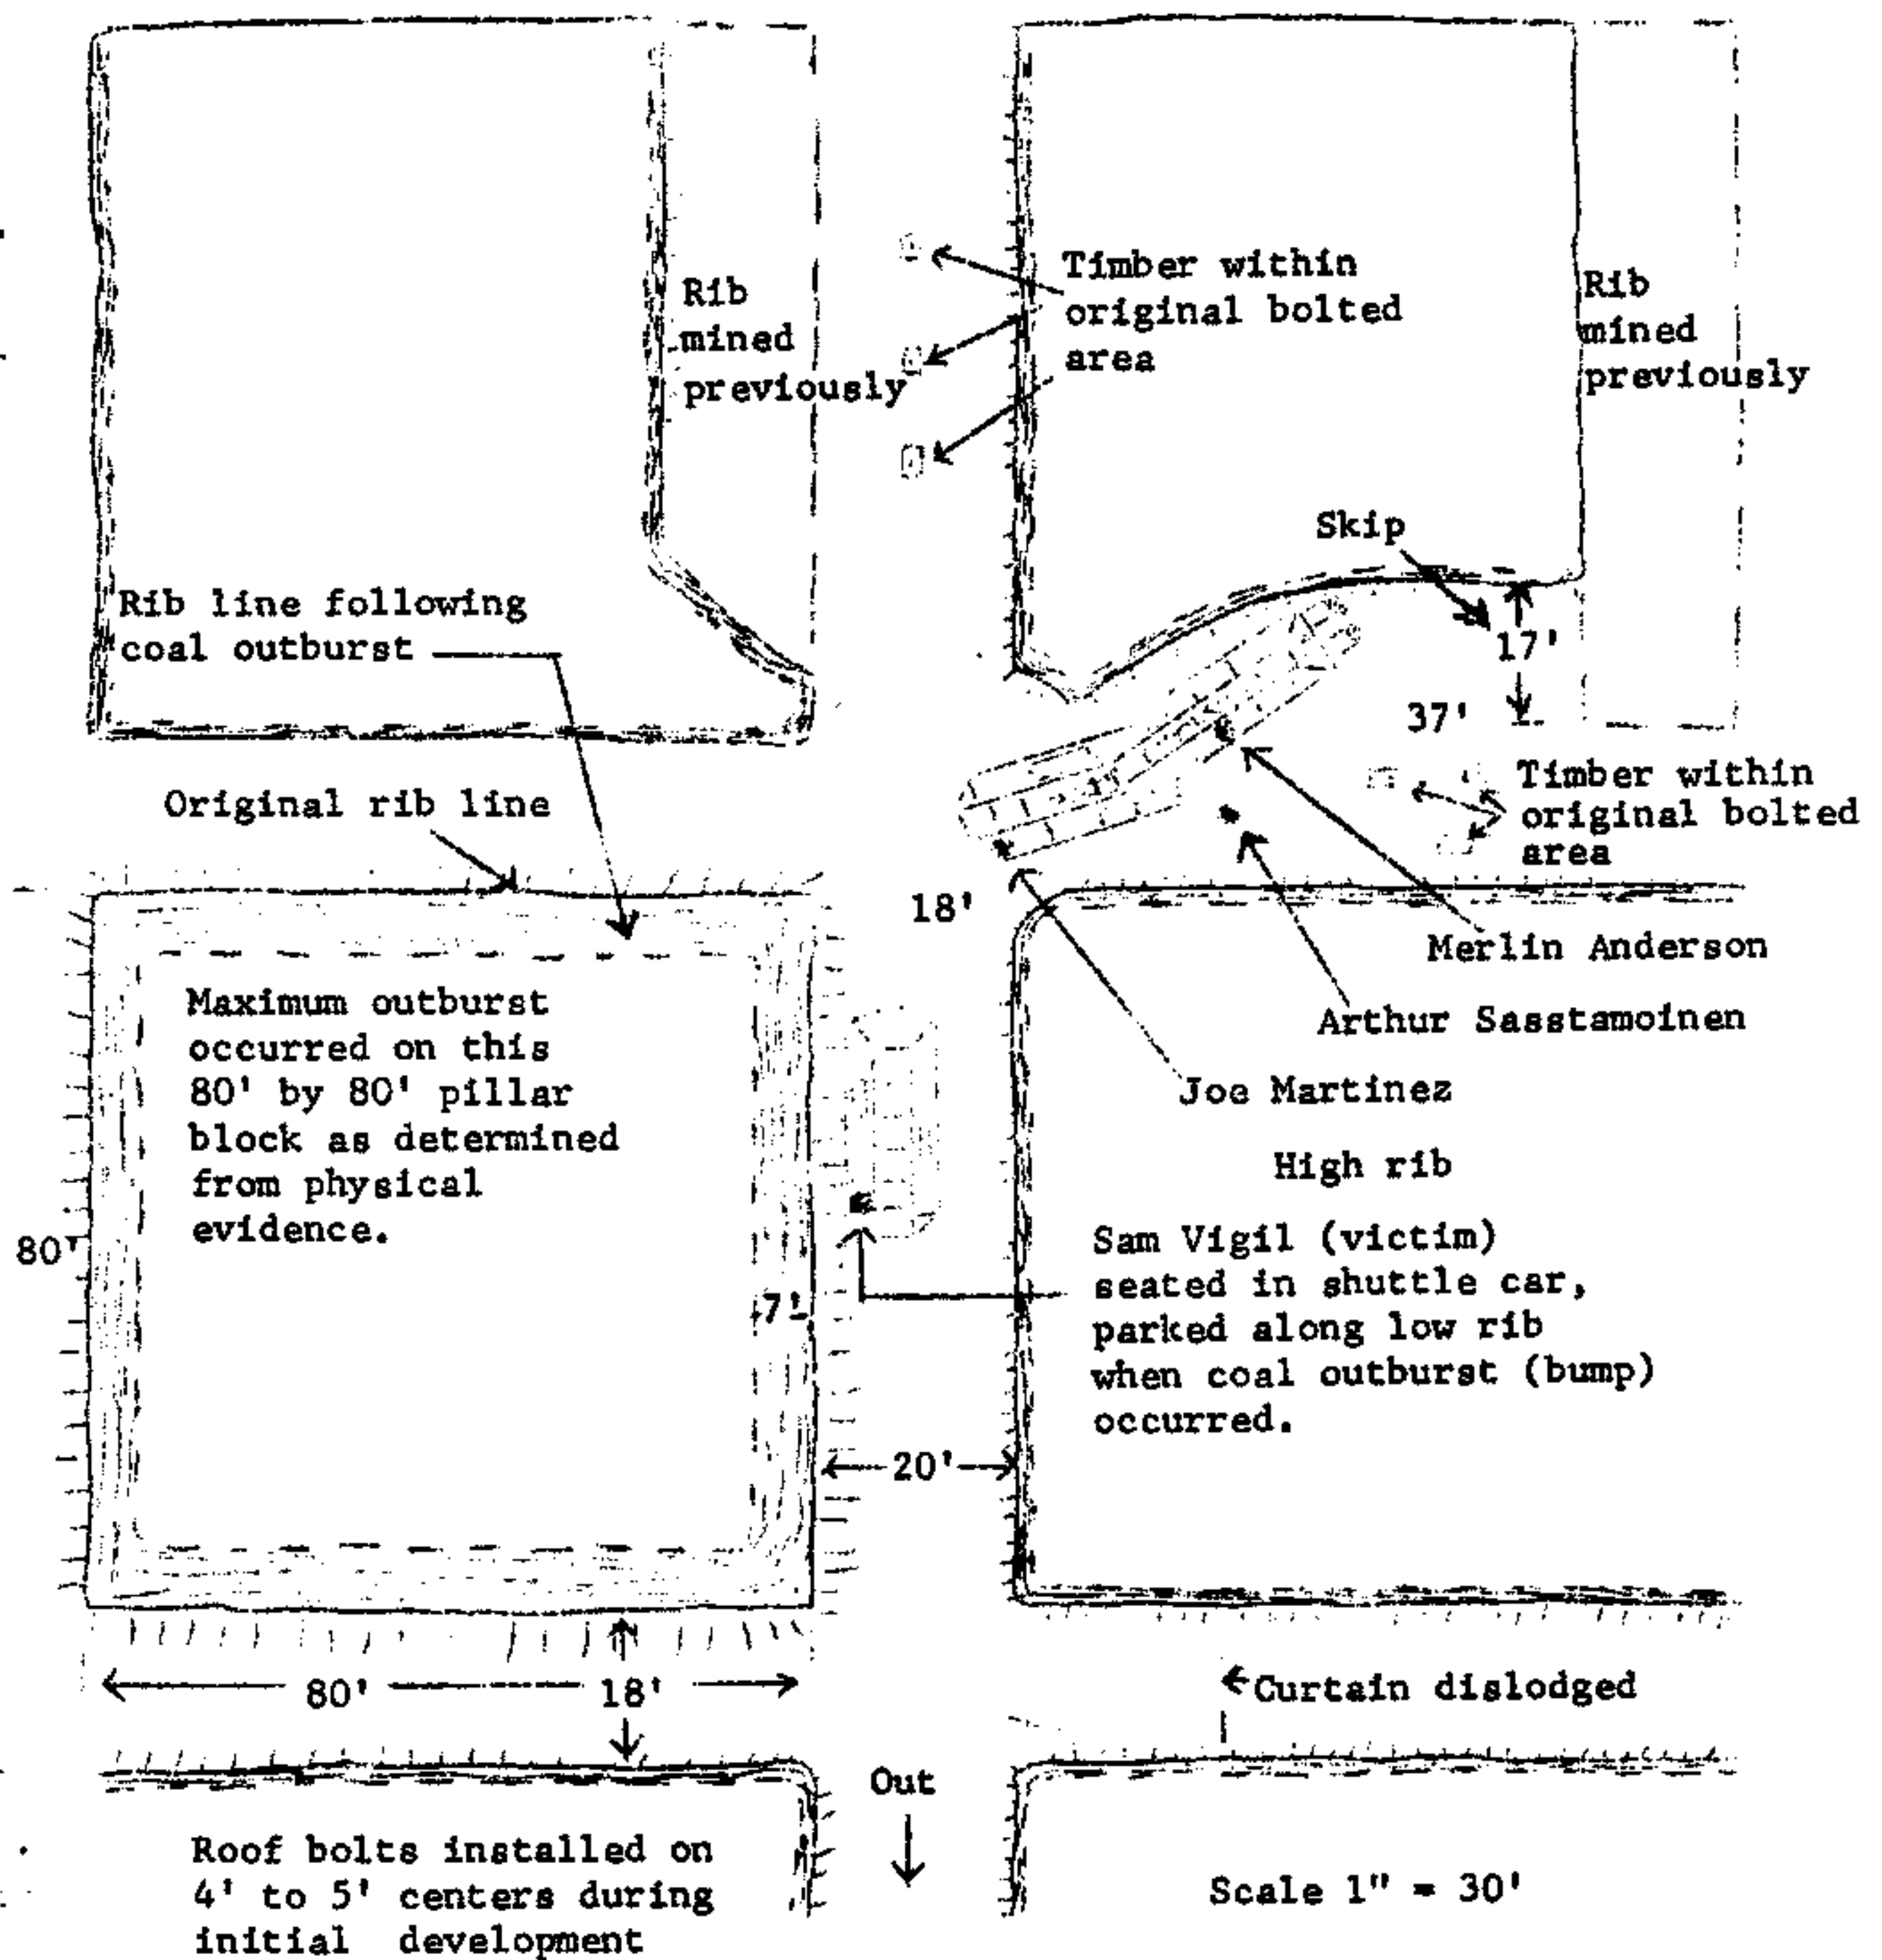
Sketch No. 2 Showing Areas  
Affected By Bounce

The ventilating system in the mine was also affected by the bump (see sketch No. 2). A concrete block stopping, outby the squeeze seal in the breakthrough between 4 and 5 east sections barrier pillar, was ruptured; fortunately, the squeeze seal was not destroyed, but was leaking along the upper edge. Twelve concrete blocks were knocked out of the roof of 5 east overcast. The sheet iron roof of the main east overcast was bent out of shape. Leaks were evident at the squeeze seals in 5 east section. Roof conditions throughout the area were not affected.

Pillar where maximum  
outburst occurred

Concrete block  
stopping outby  
squeeze seal  
ruptured

Bounce caused leak along  
upper edge of squeeze seal

12 concrete blocks knocked out of  
roof of overcast at 5 east entry

Bounce caused slight leaks  
on squeeze seals across 5 east  
entry

Sheet iron roof on main east  
overcast bent out of shape

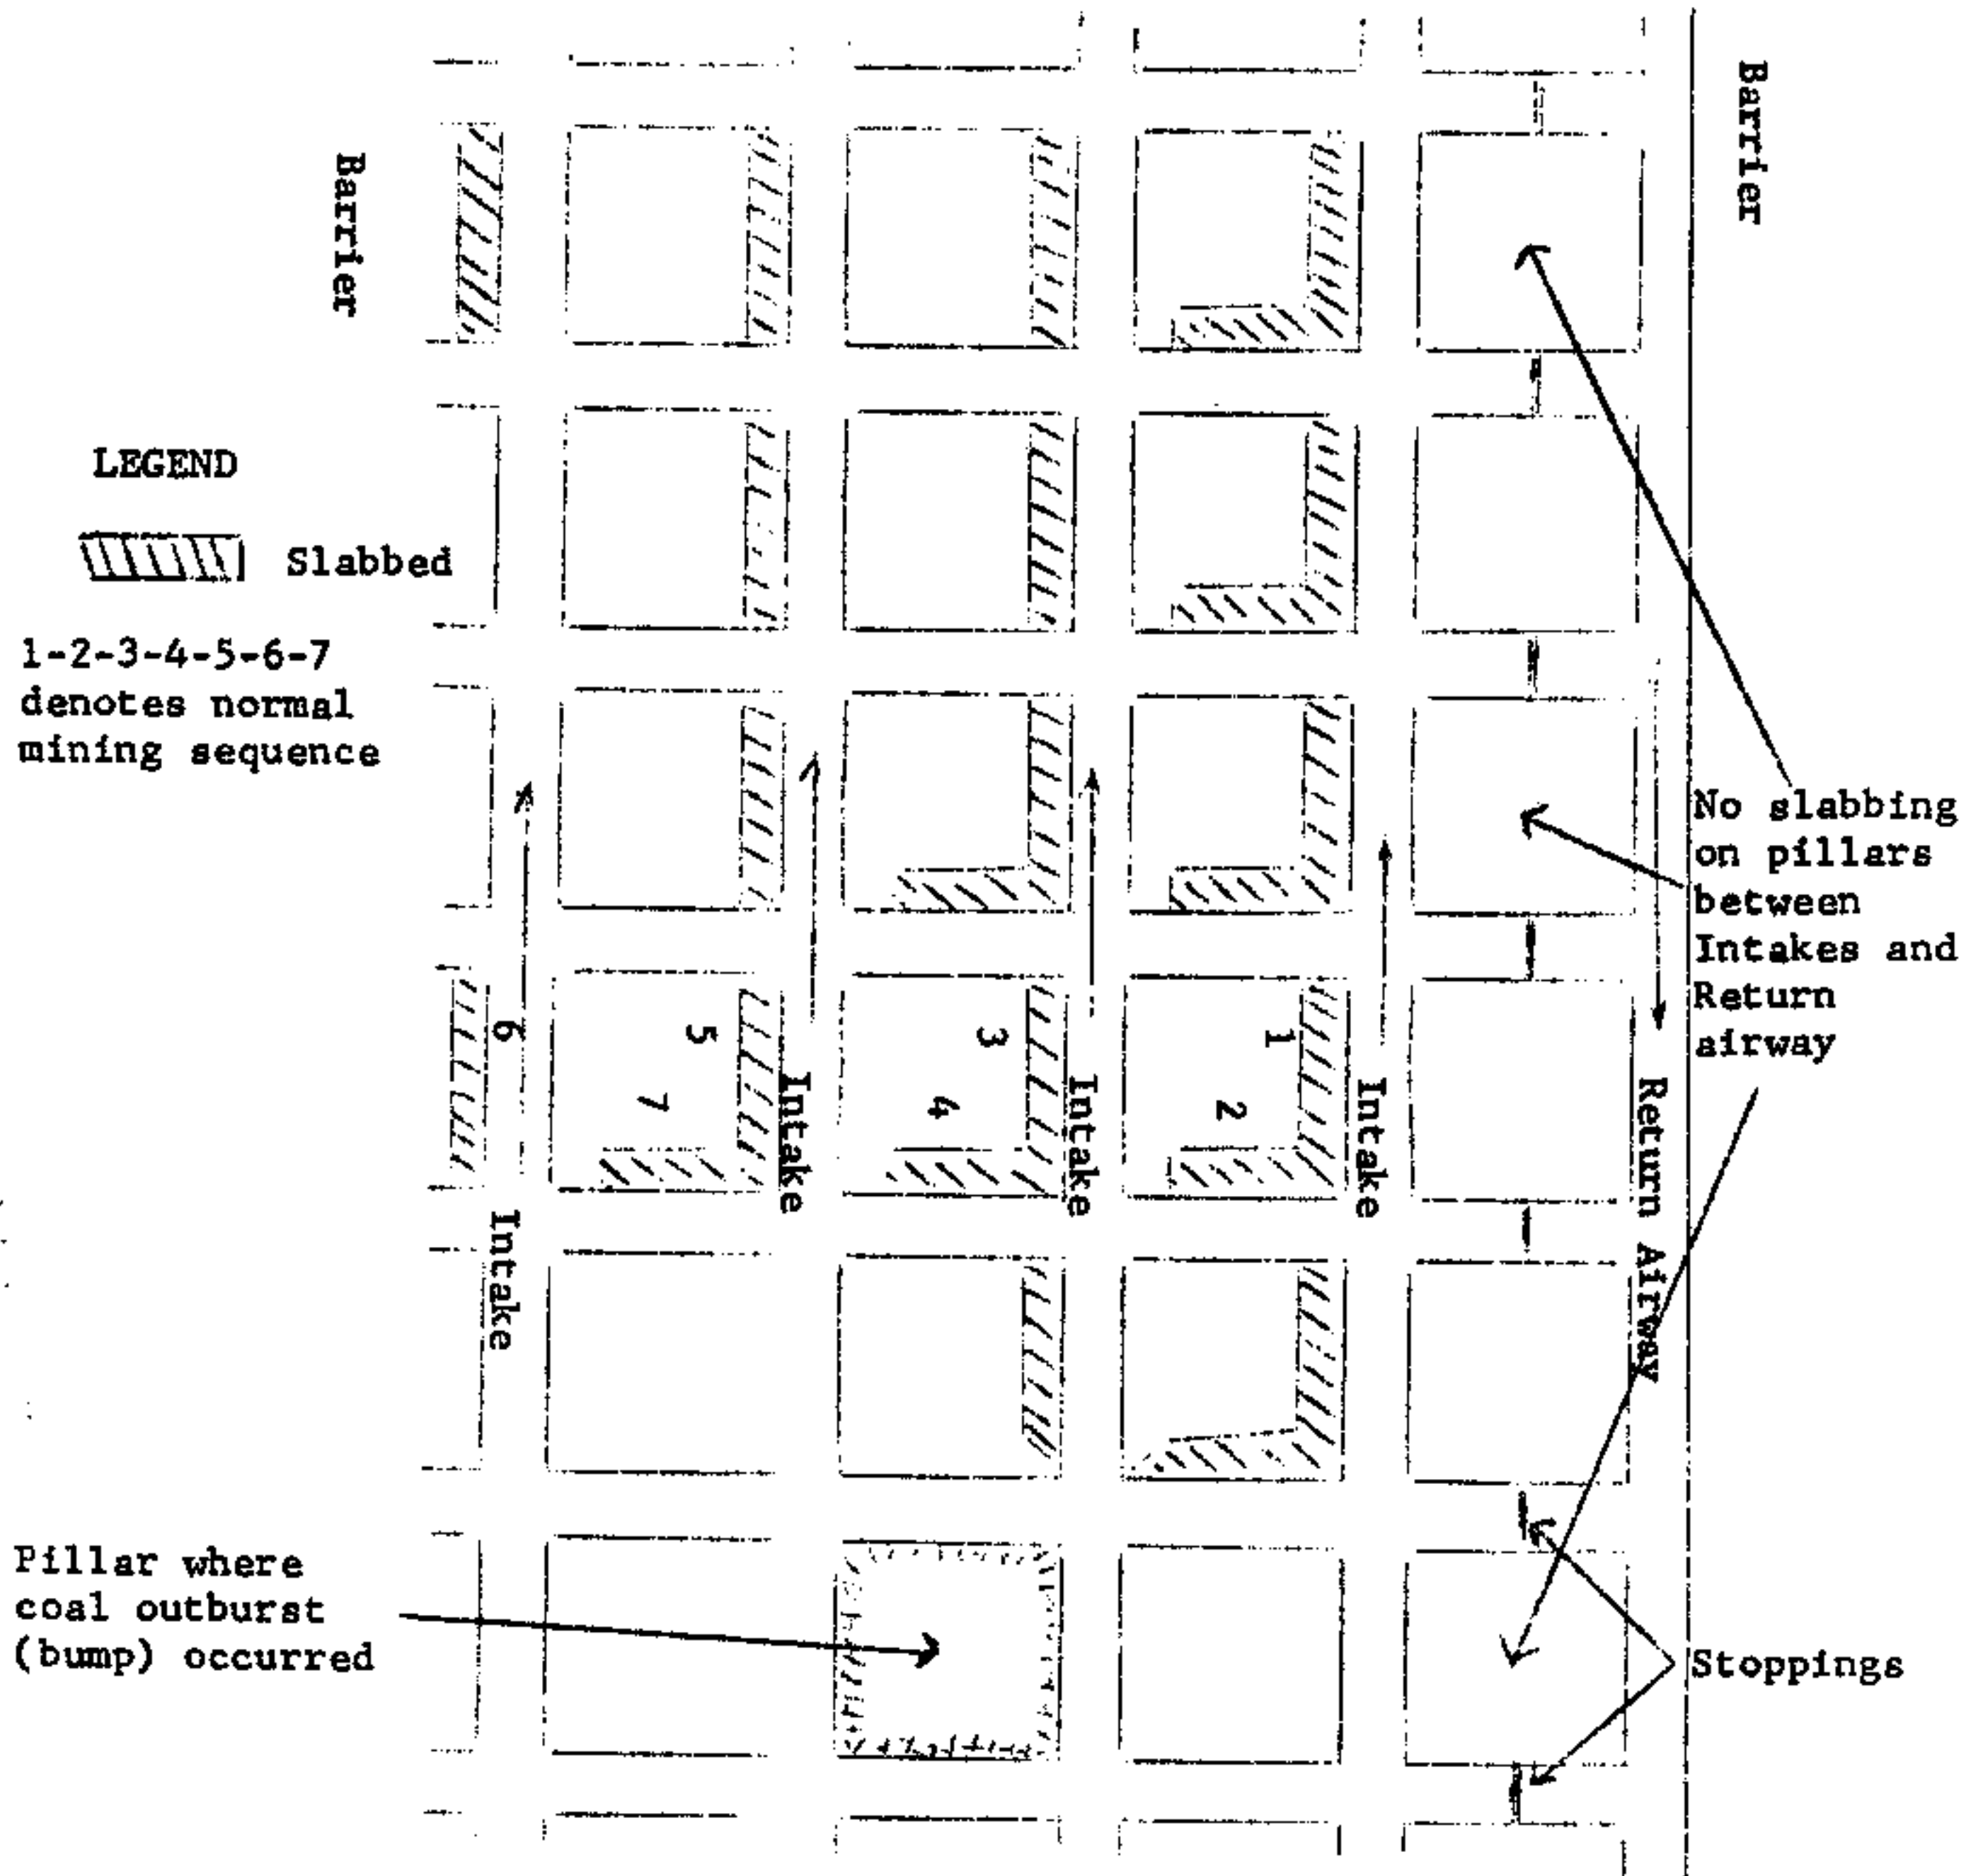
Sketch No. 3  
Showing Haphazard Pillar Slabbing  
in  
4 East Entry  
KENILWORTH MINE  
THE NORTH AMERICAN COAL CORPORATION, UTAH DIVISION  
KENILWORTH, CARBON COUNTY, UTAH

A study of the sequence map, (sketch No. 3) indicated that chain pillar slabbing was sporadic. While a system was outlined it was not followed, inasmuch as in some instances the pillar sequence varied, depending on current conditions, and then only one side of a pillar was slabbed. In addition, leaving full size pillar blocks between intakes and returns in both 5 east and 4 east sections created excessive pressure on the pillar which burst and affected other areas of the mine. Slight bumping in the area was noted during the investigation and, reportedly, increased bumping was experienced the following morning, Wednesday, April 15, 1970, practically at the same hour.

This accident was caused from mining in an area of heavy overburden and a partial pillaring plan that systematically produced pillars of unequal size causing continual shifting of stresses to the larger pillars.

1. Management should make a thorough re-evaluation of mining methods, roof and floor conditions, and depth of cover in this mine, and discontinue pillar slabbing to provide maximum protection against coal outbursts.
2. Where complete recovery of pillars is not desired, an equal amount of coal should be mined from all pillars to insure uniform size and shape, so the stresses are distributed uniformly upon all blocks.
3. Providing protective cabs on shuttle cars should be expedited.

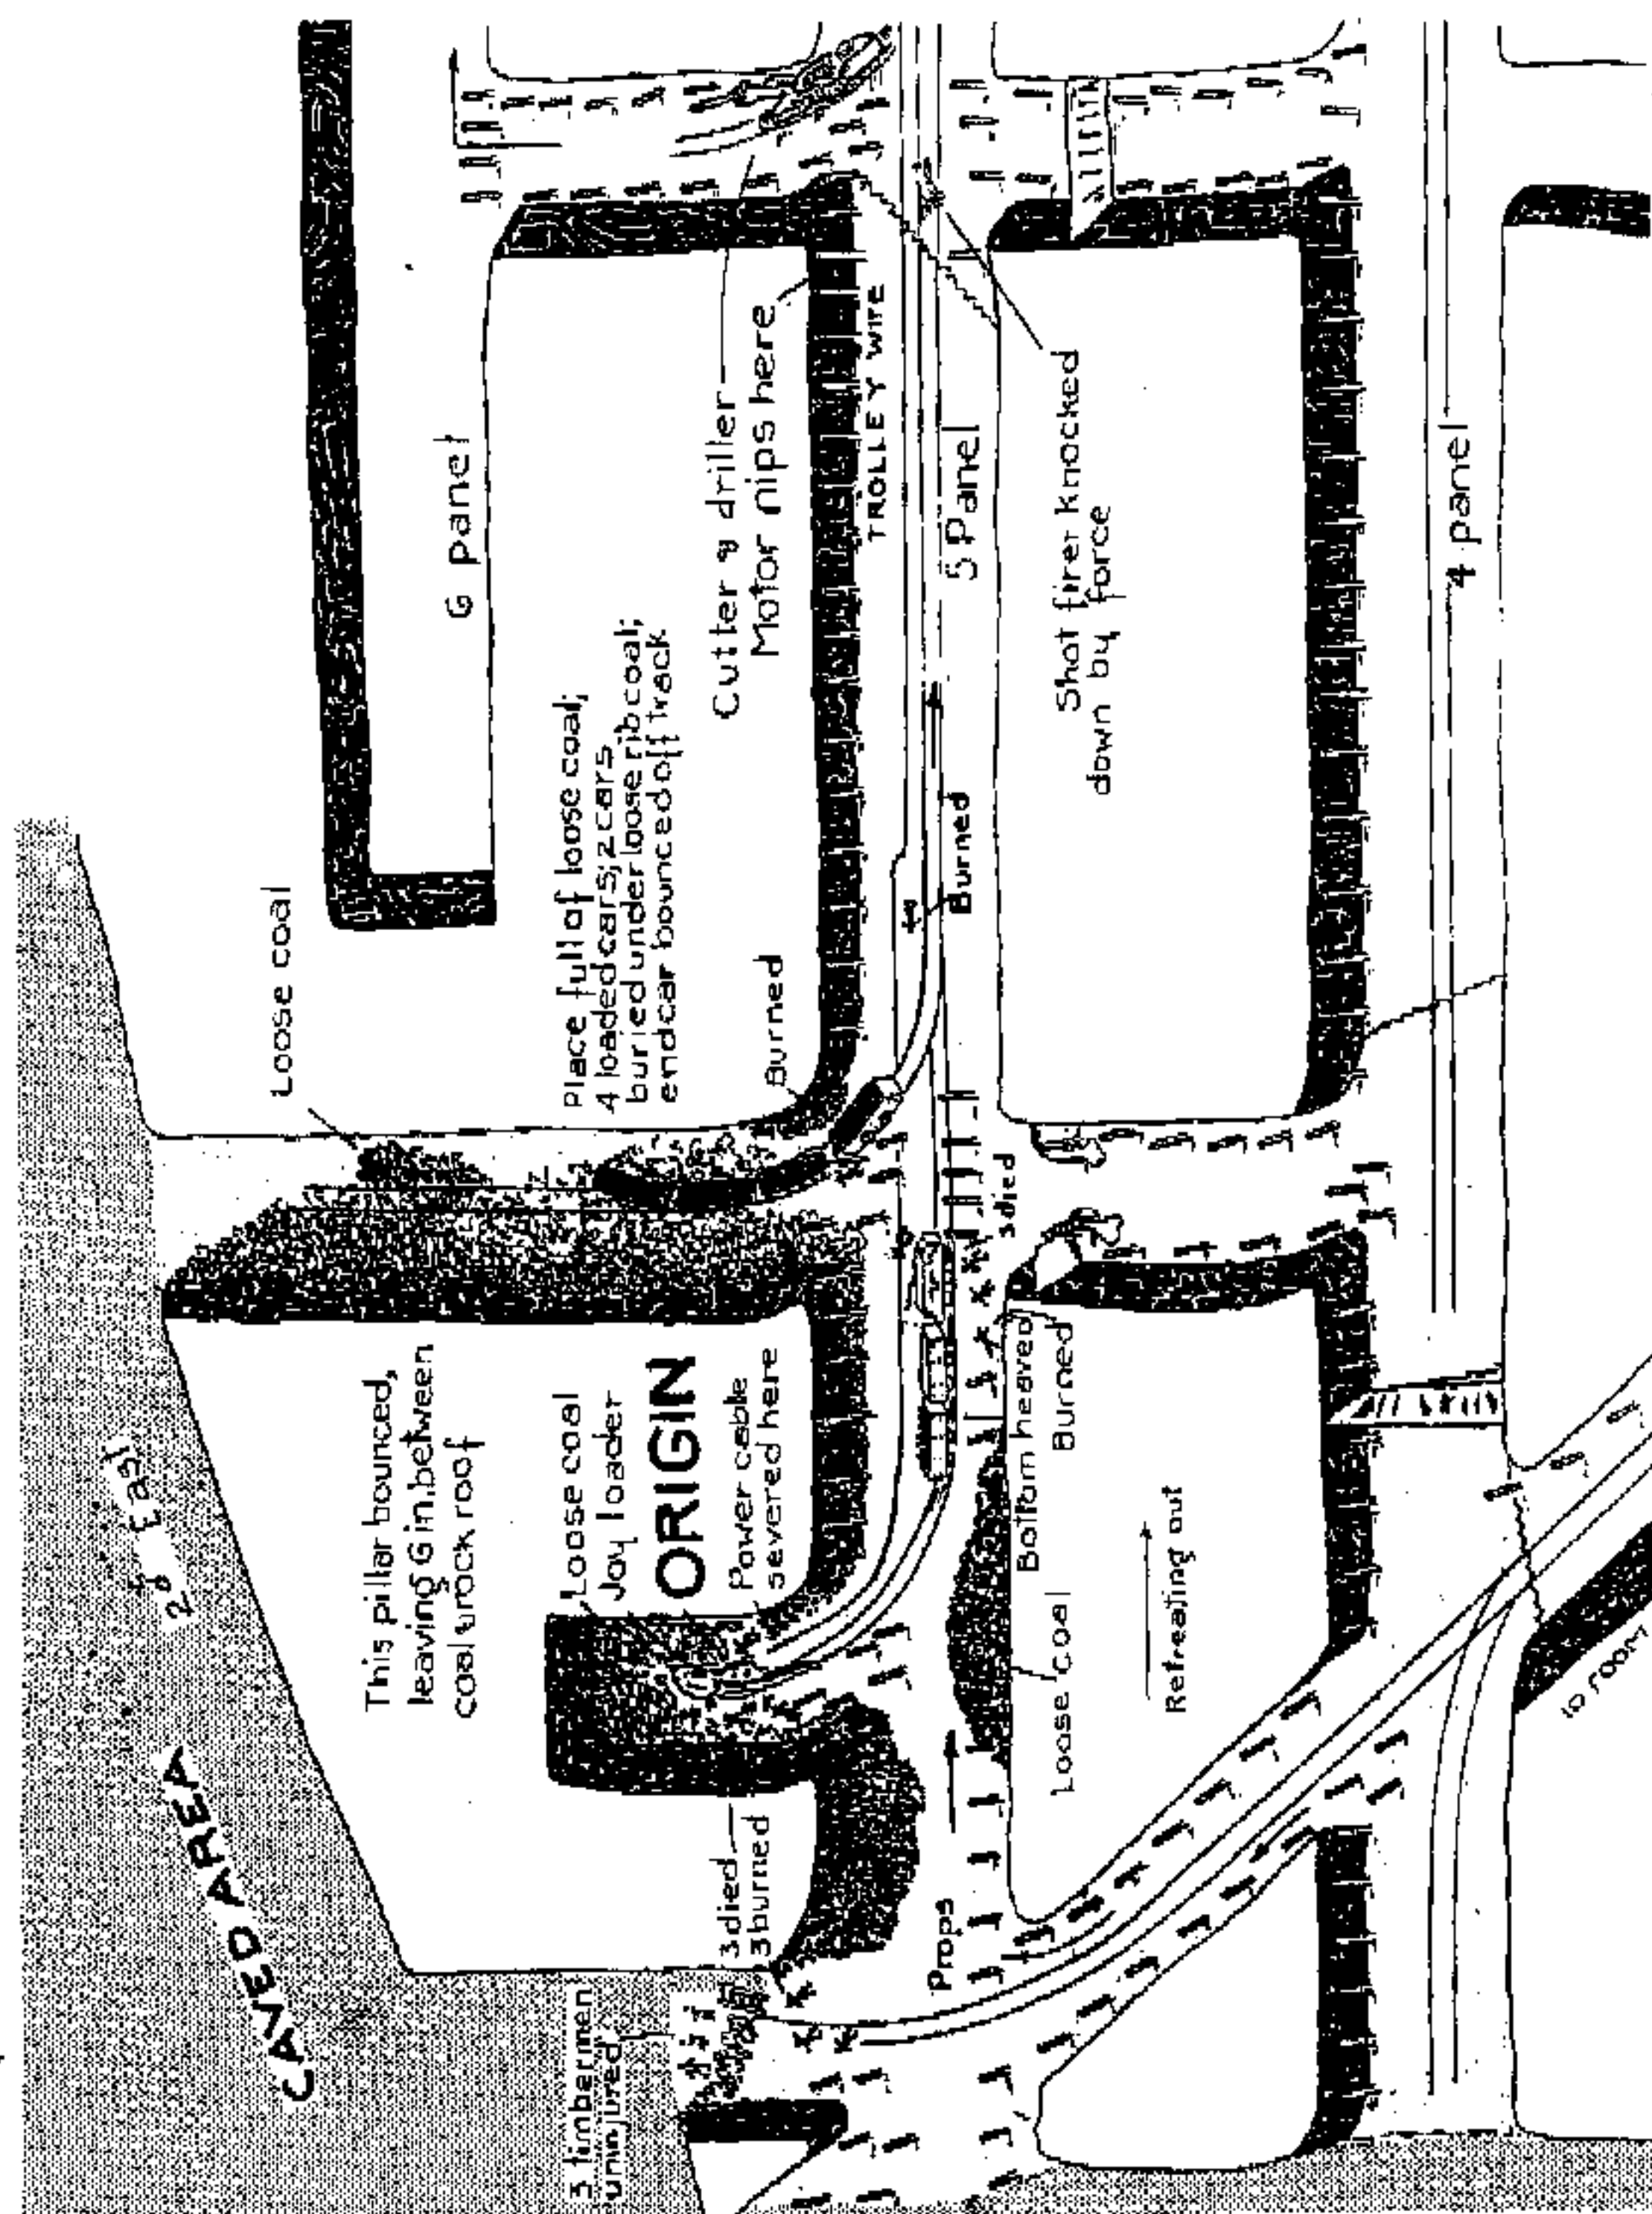
Figure 142.—Sketch of explosion area, Kenilworth mine, Kenilworth, Utah, March 14, 1945.

At 1:15 p. m. 16 men were working in No. 5 panel on the 3d east entry off No. 2 slope, when a severe bounce occurred in the pillar that was being mined next to the caved area. Although all of the electrical equipment in the panel was idle, the flying coal pulled the trailing cable of a loading machine with such force that it was severed and short-circuited on the edge of the pipe conduit entering the machine. An arc was formed that ignited the coal dust and methane in the air as a result of the bounce. Flame filled most of the area and burned 12 of the men severely. A shot firer just outside the flame was knocked down but not injured, and three timbermen also beyond the flame were not affected. The shot firer cut off power from the section and telephoned to the dispatcher for assistance. The injured men were given first aid and removed to the hospital. All men were sent out from other sections. Later seven of the injured died.

The coal thrown from 1 side of the pillar filled a crosscut to a depth above the tops of the cars, 50 inches high. A section of the pillar 60 by 40 feet had been thrown out to a depth of 6 inches below the roof. Sur-

vivors stated that the flame lasted 10 seconds or longer. The well-rock-dusted condition of the mine confined the explosion to the immediate area (fig. 142). As a precaution a method was devised later for grounding cables and fog nozzles were used to allay dust. Water saturation of pillars was also adopted.
